## **Limited Visual Dam Safety Inspection Summary Report**

**MA-084**

**Reservoir 74**

**May 2006**

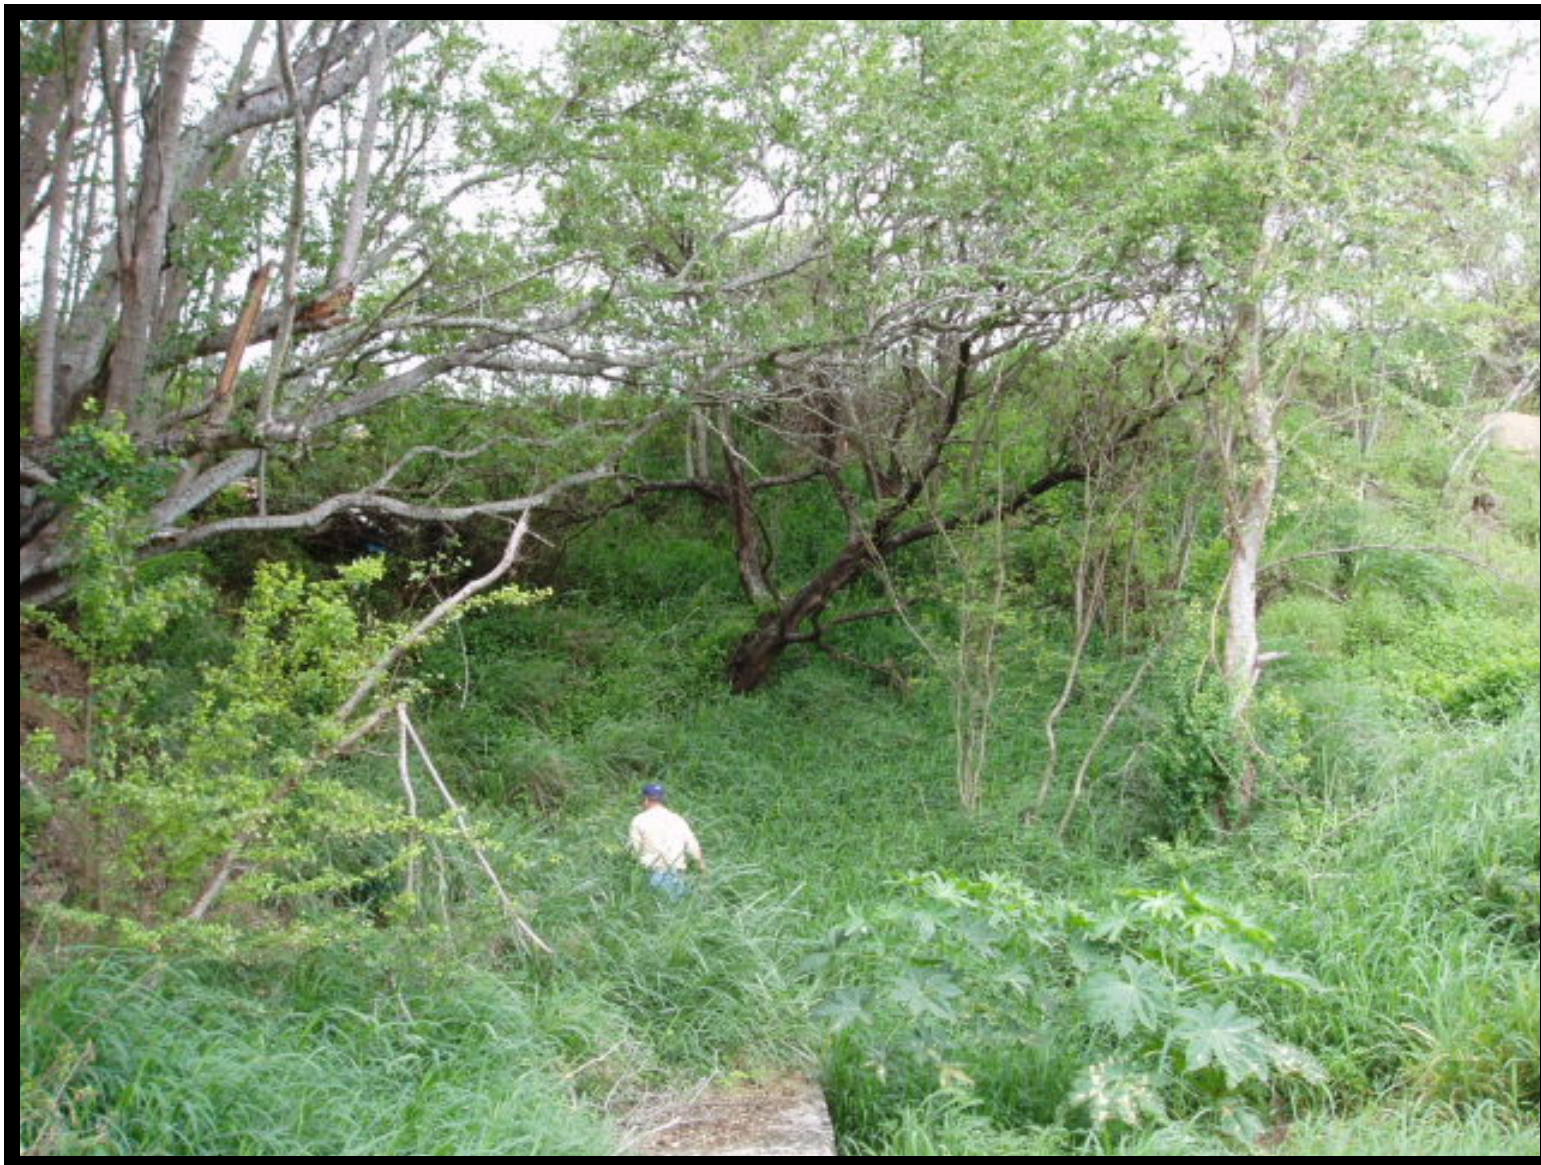
## MA-084 Maui Reservoir 74

Erosion, cracks and sinkholes were not visible, because of the dense vegetation at the time of inspection.

- a. The downstream slope appeared to be in fair to poor condition and requires corrective action.
- b. The downstream slope was not visible due to high grass and bush vegetation. Clear high vegetation and maintain low to enable easy visual inspection.
- c. Tree(s) were observed on the downstream slope. Trees have been identified as the probable cause of piping failures, and can possibly cause severe damage to the embankment if they are uprooted during high winds. Corrective action is

- d. The slope was very steep, around a 1 to 1 slope; further study is required to verify slope stability.

084 Downstream slope of the dam. Note the dense vegetation and trees on the slope.

required to remove the tree hazards from the dam. Acceptable remedies include removal of the tree and its root structure down to a 2" diameter and reconstructing the damaged embankment section. All repair work shall be accomplished as per the requirements of a licensed geotechnical or structural engineer. Routinely monitor the damaged area for signs of settlement and seepage.

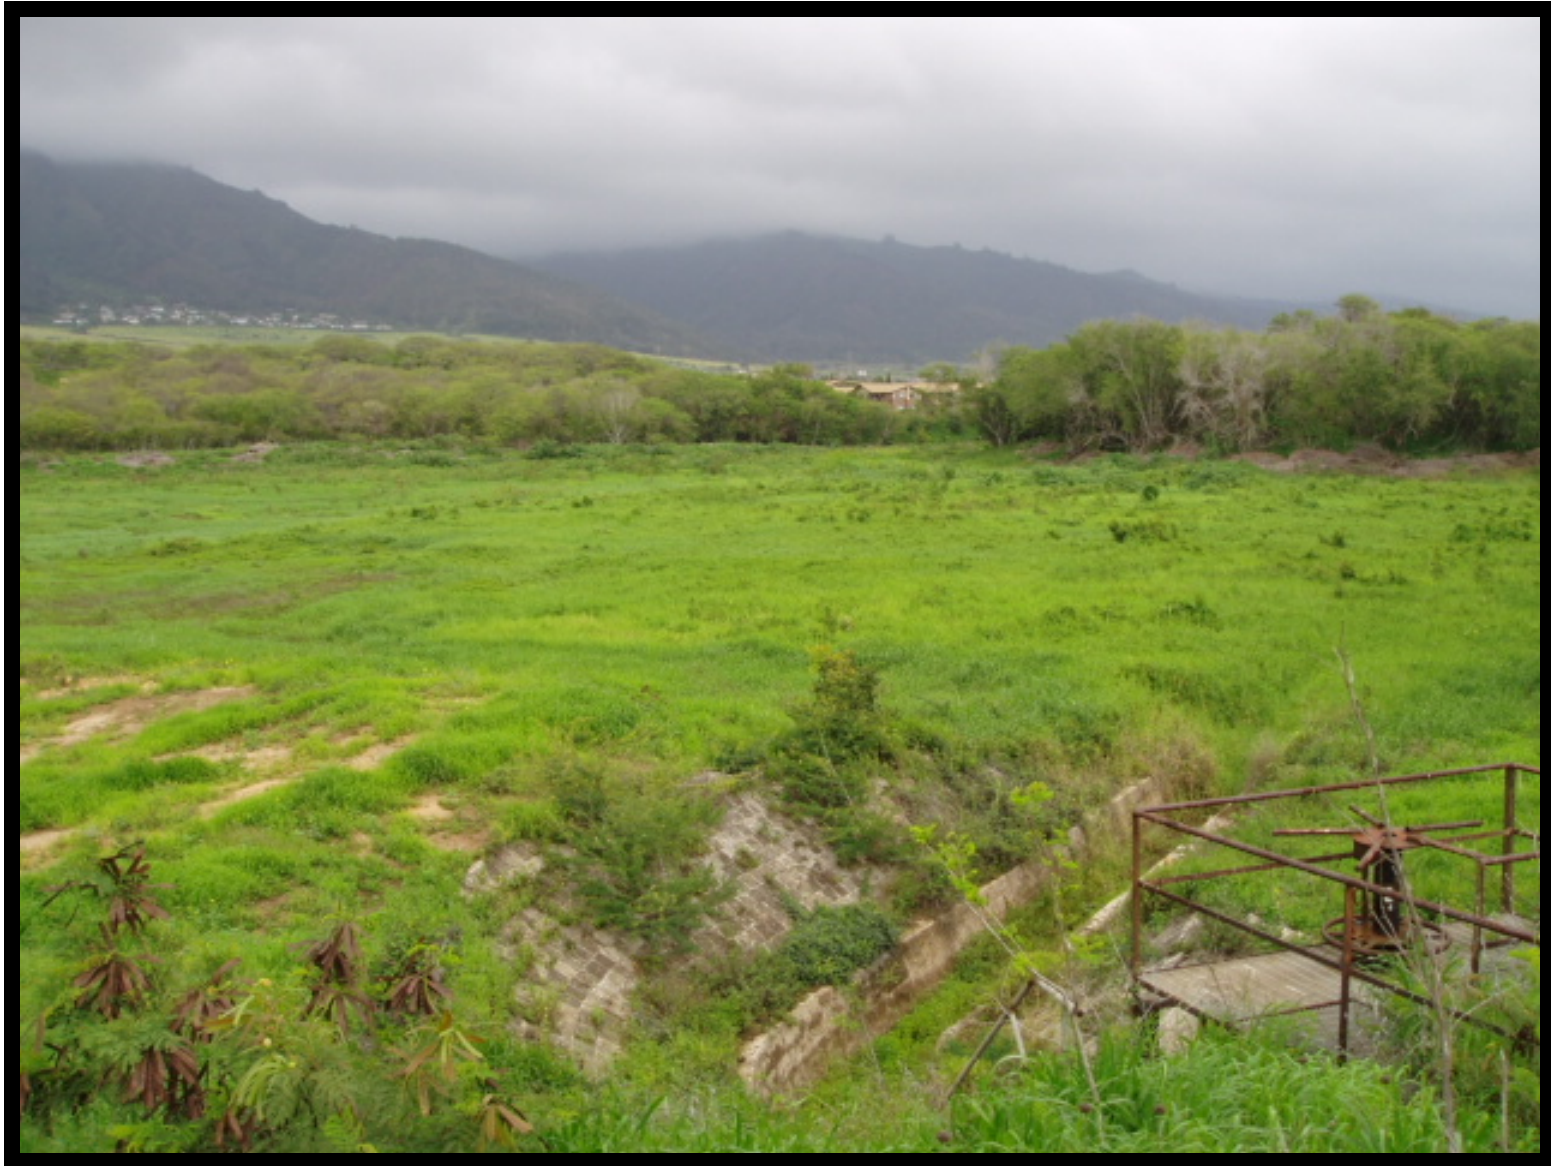
## MA-084 Maui Reservoir 74

The reservoir was empty at the time of inspection.

084 View of the empty reservoir. Outlet works in lower right corner.

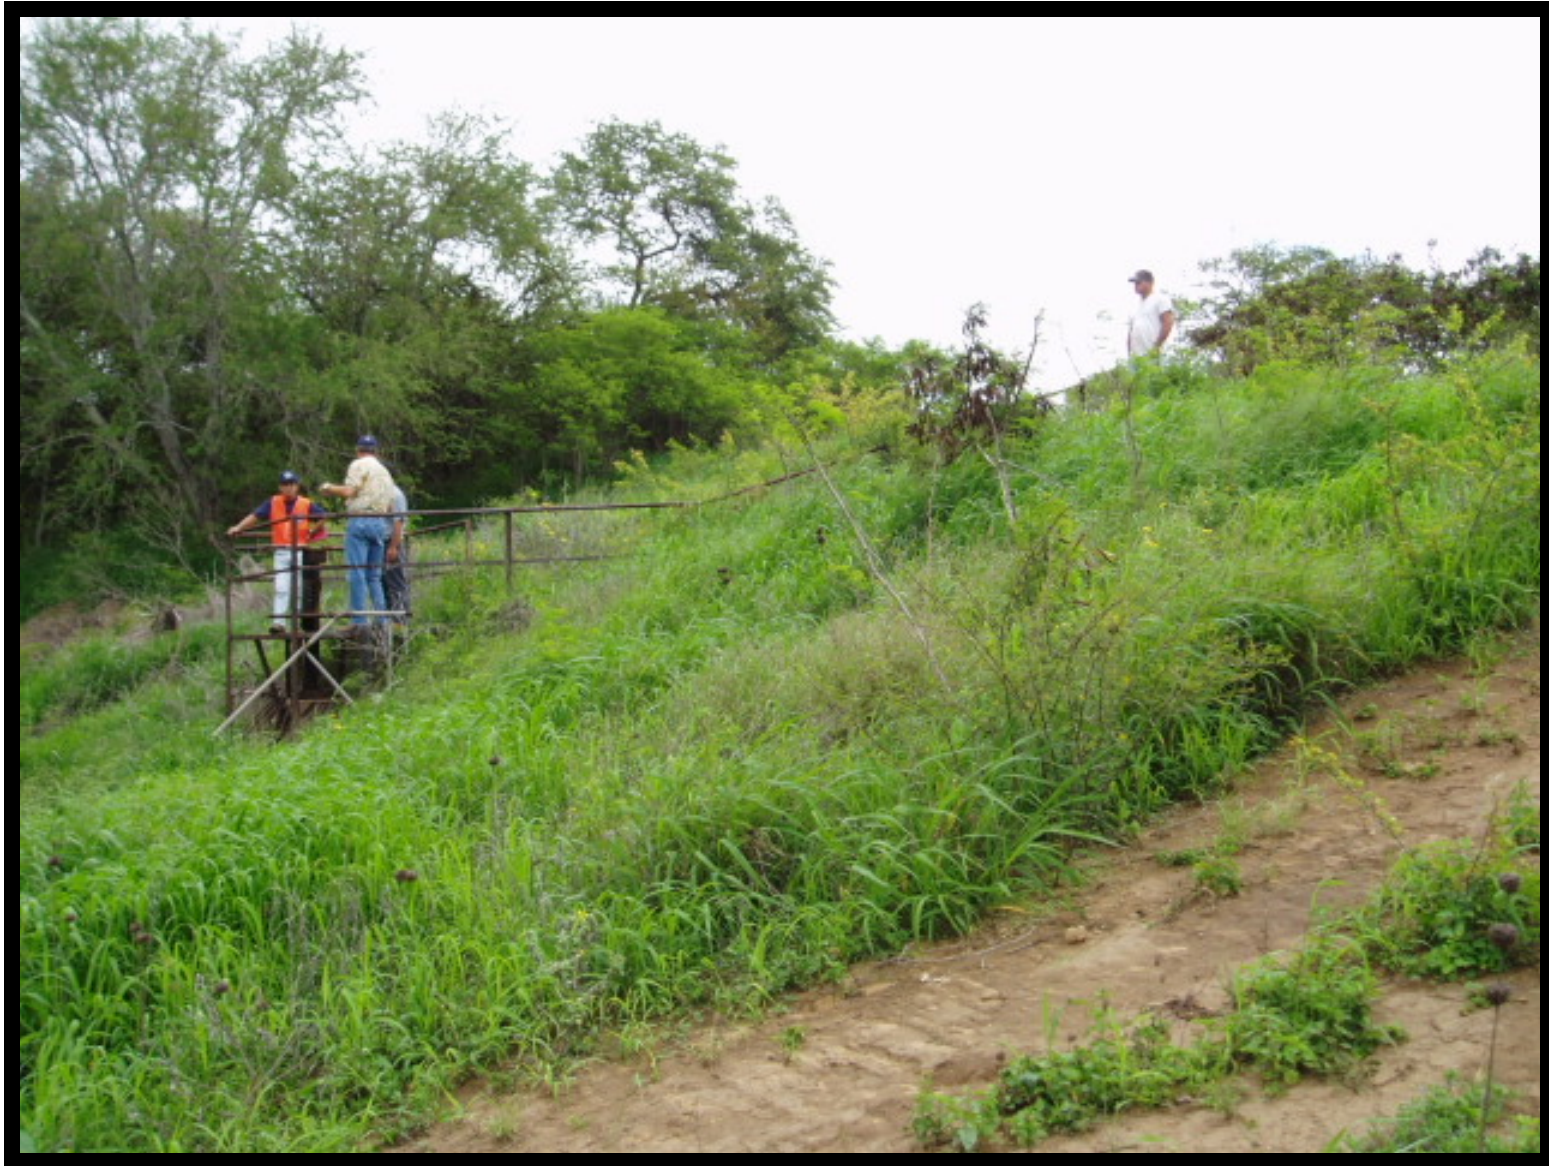
## MA-084 Maui Reservoir 74

Portions of the slope had tall grass (12" to 18"), which made inspection difficult.

- a. The upstream slope appeared to be in fair to poor condition and requires corrective action.
- b. The upstream slope was not visible due to high grass and bush vegetation. Clear high vegetation and maintain low to enable easy visual inspection.

084 Upstream slope of the dam. Note tall grass on the slope.
